**Failure Analysis
New River MCAS FRP Pipe**

Preliminary Report

December 29, 2011

Your Client:	Talon Industries, Inc.
Date of Loss:	August 9, 2011
Crane File No.:	Z7561
Crane Descriptor:	MAT - TALON INDUSTRIES - MCAS JACKSONVILLE

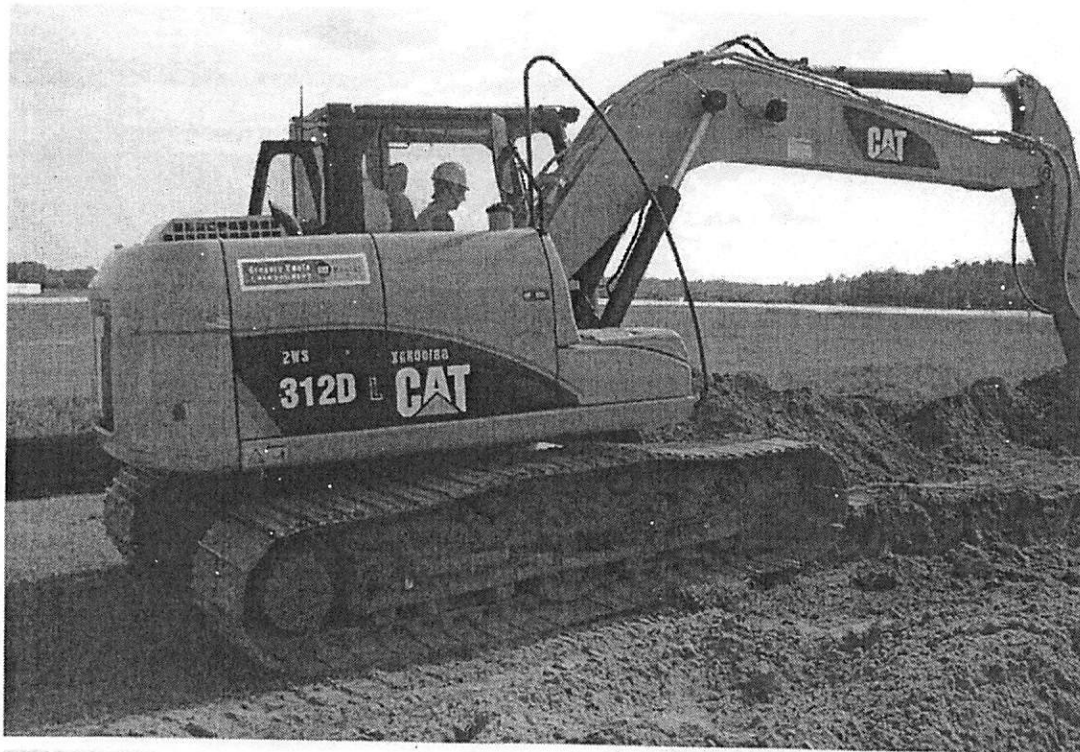
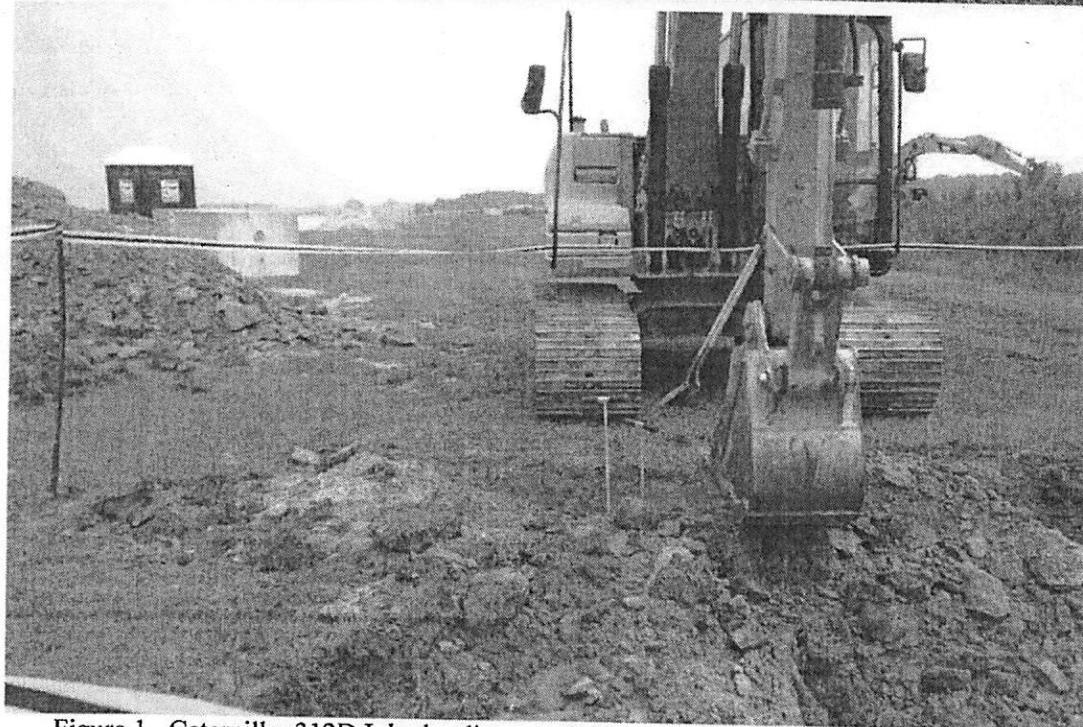
The excavator used by Talon Industries in the course of their work at New River MCAS is shown in the photographs in Figure 1, and the attached bucket is shown in Figure 2.

Figure 1. Caterpillar 312D L hydraulic excavator (images supplied by Talon Industries).

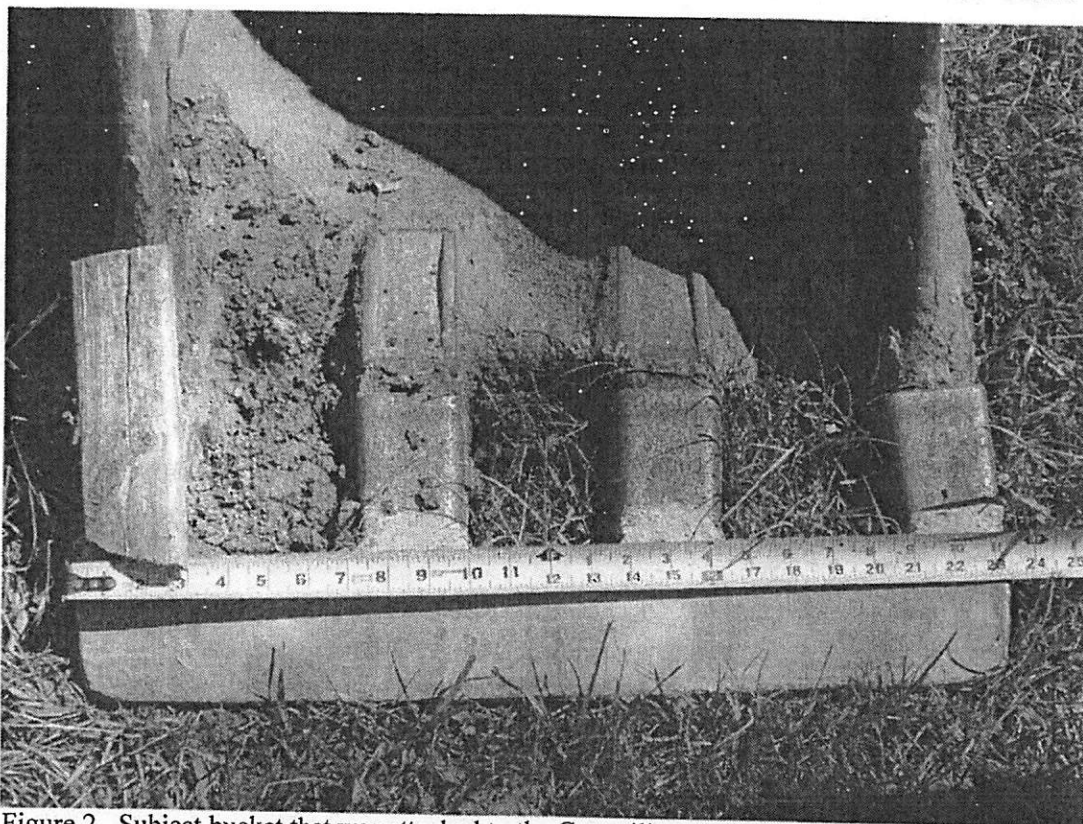
The observed shape, morphology and features of the scrape described above are consistent with damage induced by hydraulic equipment, as suggested by others [Appendix, Items 4 and 17]. However, as stated above, the shape of the damaged area can only have been made by a well-defined shape that is about 4 inches in width, such as the tooth of an excavator bucket. The teeth on the excavator bucket used by Talon Industries had a width of about 2-½ inches; however, these teeth were covered by a finishing edge that ran the entire width of the bucket, approximately 24 inches, as shown in Figure 2. Moreover, no abrasion witness marks were found to the pipe outer diameter (OD) surface immediately adjacent to the edges of the scrape. Had the FRP pipe been abraded by the 24 inch finishing edge on the Talon bucket, then one might reasonably expect abrasion to the OD surfaces at each side of the scrape. None were observed. These observations effectively rule out the Talon excavator equipment as the source of this damage. Likewise, the damage could not have been caused by a shovel.

Figure 2. Subject bucket that was attached to the Caterpillar excavator shown in Figure 1 (image supplied by Talon Industries).

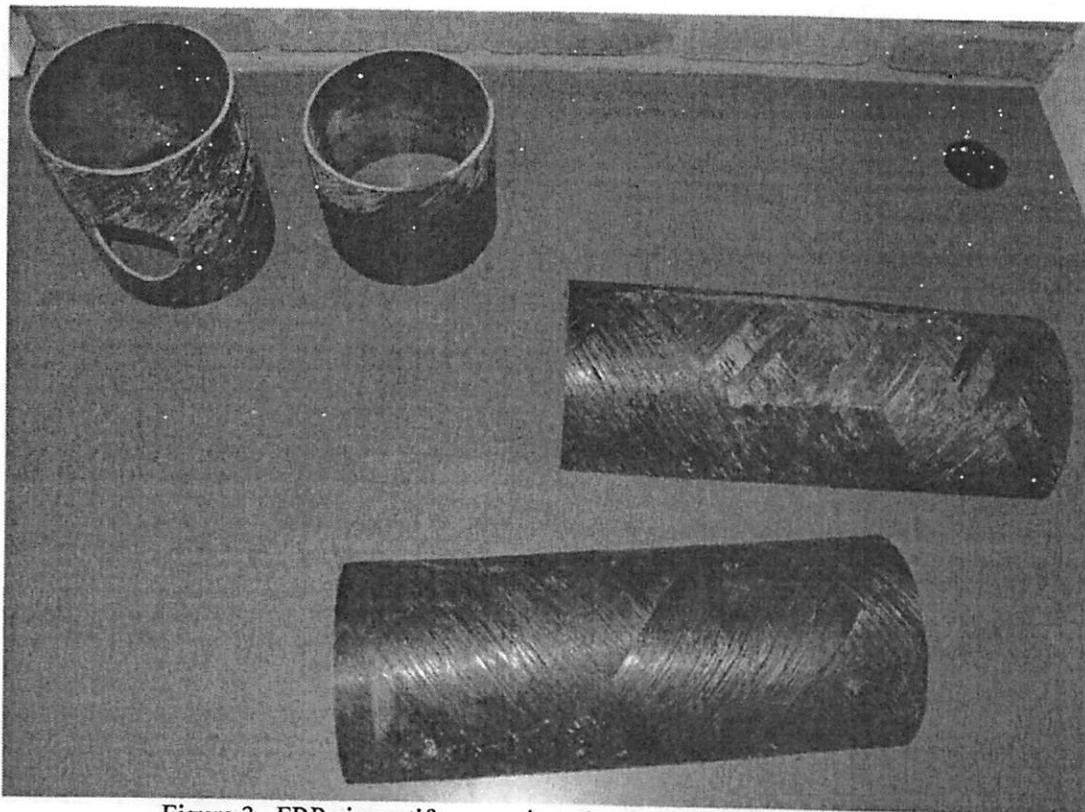
The subject FRP pipe is shown in Figures 3 and 4, in the condition in which it was first inspected at MDE on October 19, 2011. The pipe artifact, initially about 30 inches in total length, had been cut into three pieces by MDE. The longer piece (about 17 inches long), containing the damaged area, received an additional axial cut to expose the inner surface of the pipe, as shown in Figure 3.

Figure 3. FRP pipe artifacts as viewed on October 19, 2011 at MDE.

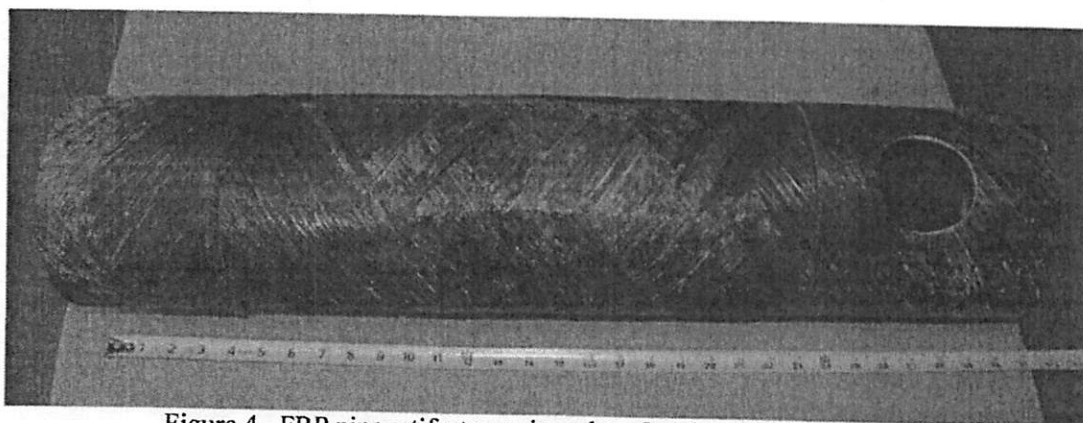
Figure 4. FRP pipe artifact as viewed on October 19, 2011 at MDE.

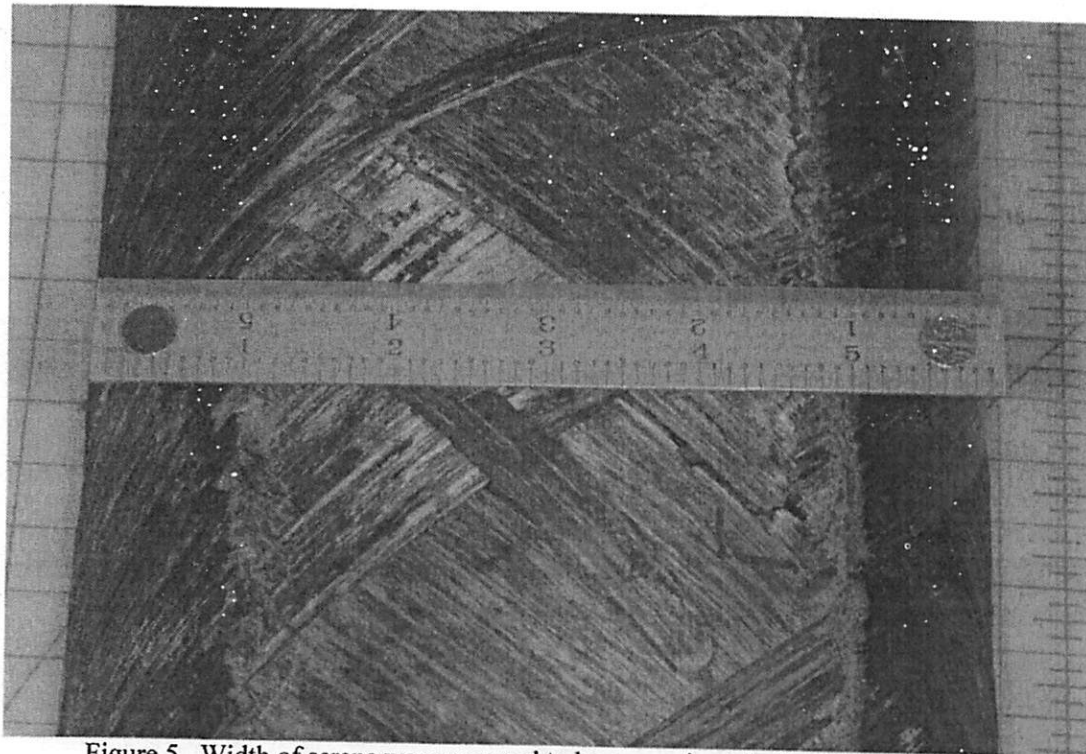
The "scrape" on the subject pipe, shown in Figures 5, 6, 7 and 8 is approximately 14 inches long and is defined by a region in which substantial loss of the fiberglass material had occurred. That is, several layers of the fiberglass winding were missing in this area. The scrape is substantially uniform in width over most of its length, and was measured to be approximately four inches wide, as shown in Figure 5.

Figure 5. Width of scrape was measured to be approximately four inches in width.

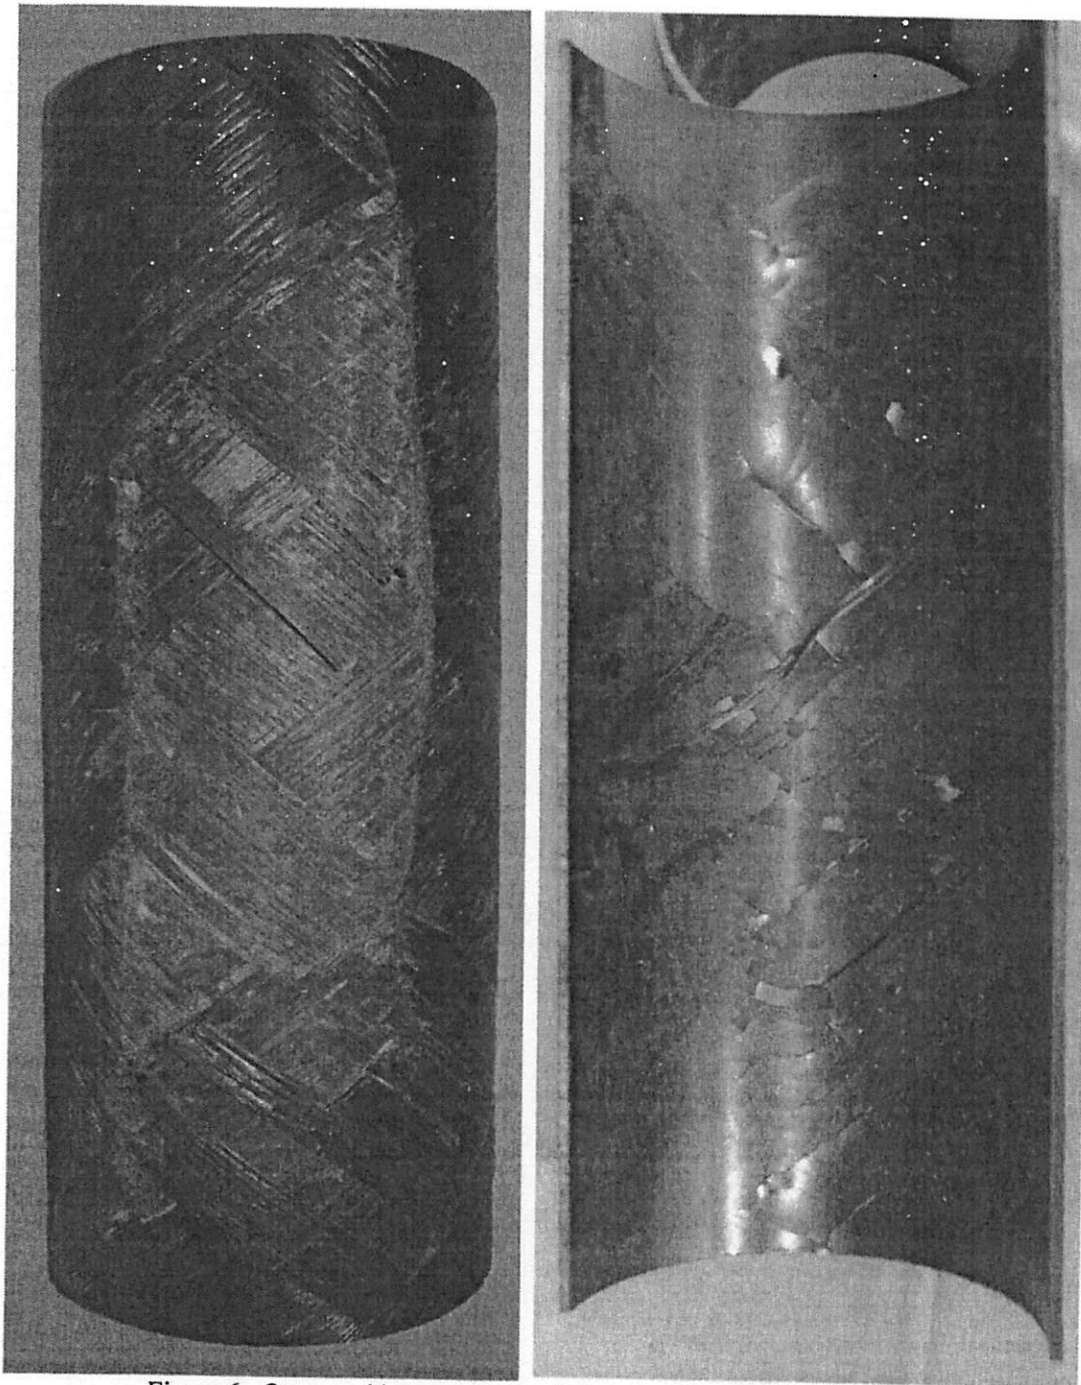
The damage to the pipe was found to extend through the wall, and has manifested as cracking and splintering to the "C-Veil" coating that lines the inner diameter of the pipe. This is shown in the right-hand photograph in Figure 6. This damage to the inner pipe surface is consistent with an inward directed force or load applied to the outer surface of the pipe.

Figure 6. Outer and inner surfaces of pipe at the location of the scrape.

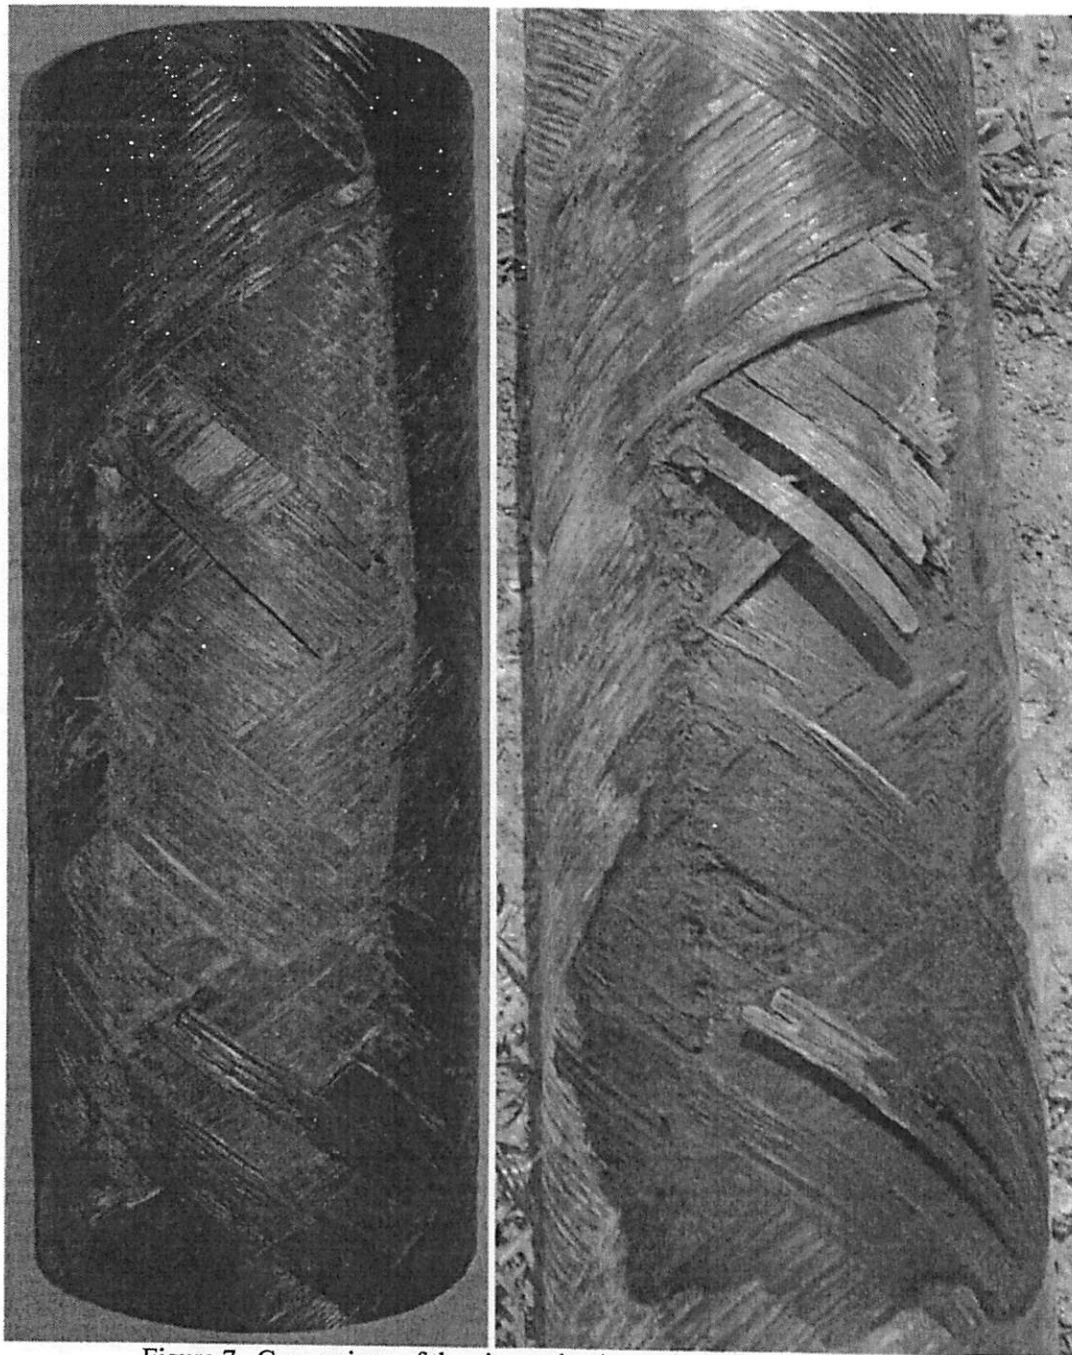
Figure 7 provides a photographic comparison of the subject FRP pipe as viewed at MDE on October 19 (left-hand photograph) vs. when it was removed from the ground, at the time repairs were made to the subject pipeline, by APS on August 17, 2011 (right-hand photograph). Clear differences in appearance are noted. The photograph taken at the time the 30-inch damaged pipe segment was removed from the ground shows it to be substantially covered with soil with visible signs of apparent residue from the spilled JP-5 jet fuel. In contrast, when inspected at MDE, the artifact was substantially cleaner, with no visible sign of the fuel residue, and much of the soil missing from the surface of the pipe. Furthermore, no significant odor was detected. No report or documentation has been received concerning this significant change in the artifact. These observations suggest that the artifact had been washed, or otherwise cleaned, without notification to the interested parties.

Figure 7. Comparison of the pipe at the time of excavation (right) to its appearance when viewed at MDE (left).
